# **New ecological and sustainable solution for protecting architectural metals using an ecologically friendly biological treatment**

Final Report, 30 April 2018

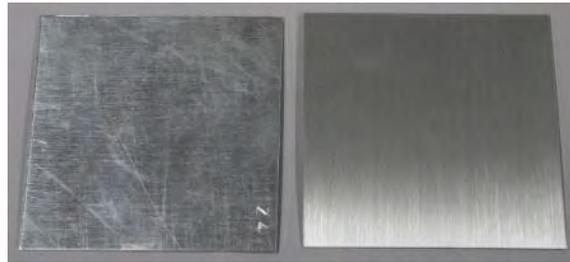
Figure 1- Example of a zinc coupon before (left) and after machine processed grinding (right)

coupons (5X5 or 6x6 cm) were produced using metal sheets. The surface finish chosen for the bare metals was a brushed (satin) finish as mirror-polished surfaces. Although these do not represent architectural metal parts, it is important to have homogenous reproducible surfaces that can be compared before and after treatment and from one series to another. The soft bare metals like tin and aluminum that were more difficult to handle were abraded manually with grinding paper (1913 Siawat<sup>®</sup> granulometry 1000 and 1200, SIA). Harder metals like copper, steel and zinc were prepared by a company in Neuchâtel (Gravadhoc). These coupons were also abraded with grinding paper but machine processed. All bare metal coupons were washed in ethanol and acetone and dried in air. In all cases, regular parallel grinding marks were obtained (Figure 1).

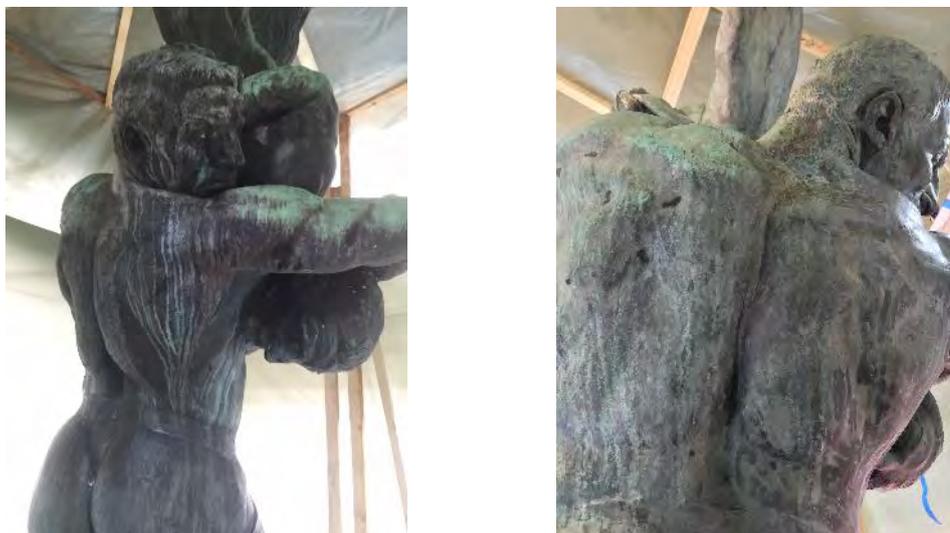
Figure 5 – Wrestler group exposed in Lucerne, before (left) and after (right) biopassivation treatment. Tests performed under the supervision of the conservator-restorer Wolf Meyer zu Bargholz.

Based on the promising results presented on bronze substrates in the previous report, further experiments were carried out in order to ascertain the protectiveness of the biological treatment on real artifacts. In particular, the wrestler group exposed in Lucerne, Switzerland where both sheltered and unsheltered areas are presented was treated through biopassivation (Figure 5). In situ measurements campaign should be performed in order to confirm the color change observed after treatment. However the results indicated clearly the formation of both copper and tin oxalates as observed on artificially tin-enriched coupons and presented in the previous report.

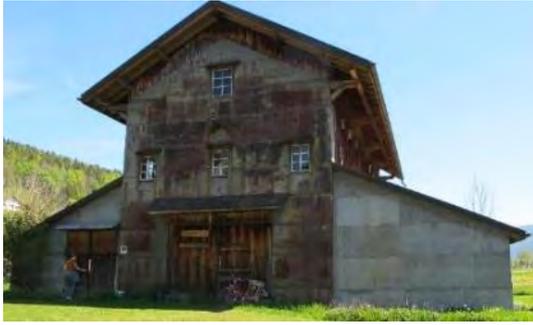
Figure 6- General view of the western side with heavily corroded metal sheets

The facade (with the entrance to the dryer) on the western side has a very heterogeneous surface conditions. The whole facade is covered with metal sheets, but the elements on the middle part of the building are more heavily corroded than on the rest of the building (Figure 6). These sheets corroded strongly, revealing red-brown rust spots. There's a metal panel above the main entrance with the inscription *BUCHER*. On this panel the remains of an orange paint can be seen. The same paint could also be present in the form of residues on the metal sheets (Figure 7).

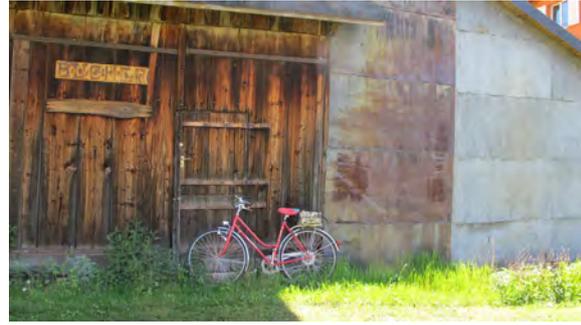
Figure 7- detailed view of the damaged metal sheets and the painted panel

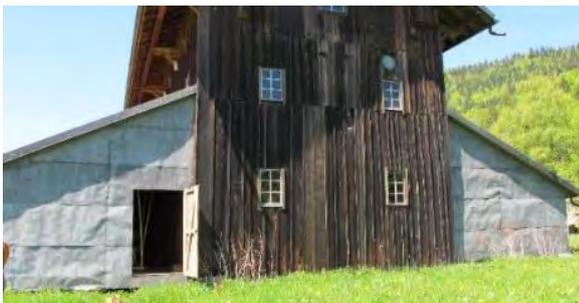
Figure 8- general view of the east-side

One metal sheet located on the backside of the northern side of the building was chosen for the tests (Figures 8-9). Another zone on the frontside of the building was initially selected for some tests with biopatina. Unfortunately, the setting didn't withstand the storm. For this reason, test results aren't available for this zone (see location and preliminary characterization in appendix 3)

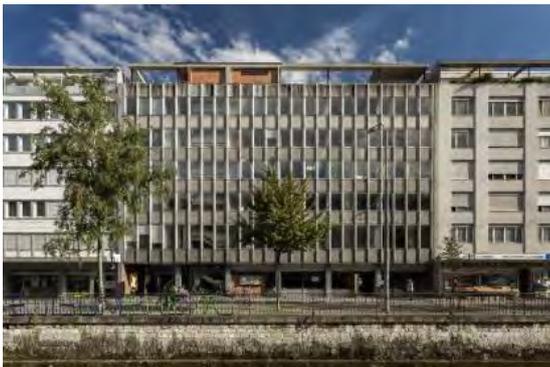
Figure 10- General view of the eastern front of the Farelhaus and its curtainwalls (© W. Gassmann AG/SA 2017)

The Farelhaus is located in the center of the city of Biel (Quai du Haut 12, 2502 Bienne). It's the youth work of the architect Max Schlup and an important witness of the architecture of the late fifties. This building is listed as a cantonal heritage. In the 50s, the architect Max Schlup from Biel executes the Farelhaus for the reformed parish of Biel. The project is characterized, among other things, by its not-to-be-missed facade but also by the choice of materials used and the spaces layout. The construction includes curtain-walls. The elements are made both of aluminum and anodized aluminum (Figure 10).

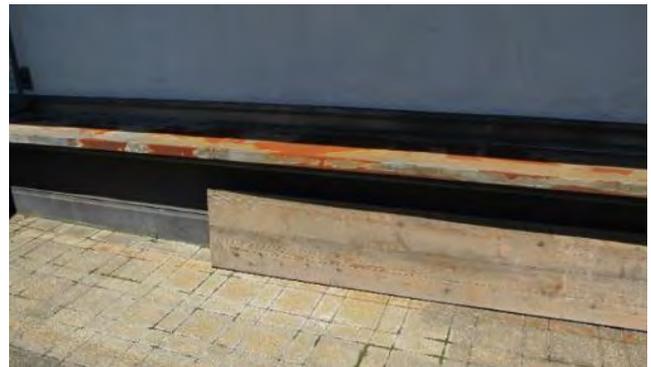
Figure 11- General view of the bench located on the north east side

A bench covered with galvanized iron sheets was also located on the rooftop (Figure 11). Another zone, located on the roofledge (aluminium alloy) was initially selected for some tests with biopatina. Unfortunately, the setting didn't withstand the storm. For this reason, test results aren't available for this zone (see location and preliminary characterization in appendix 4).

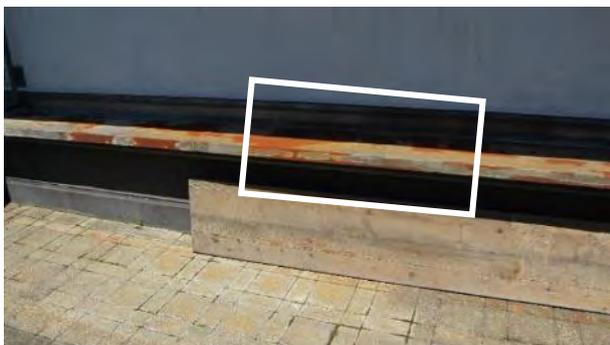
Figure 12- General view of the bench located on the north east side and localization of the test zone

The surface of the bench located on the rooftop on the northern side of the building was assessed. It is covered by a zinc coated iron sheet (Figures 12-13).

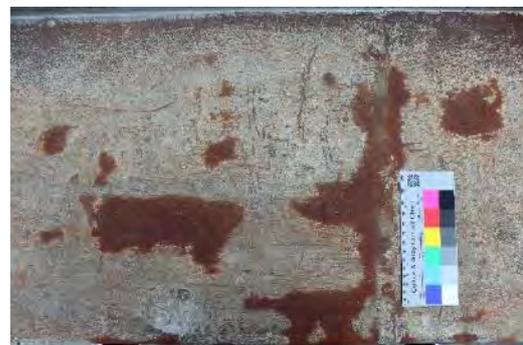
Figure 13- Detailed view of the test zone

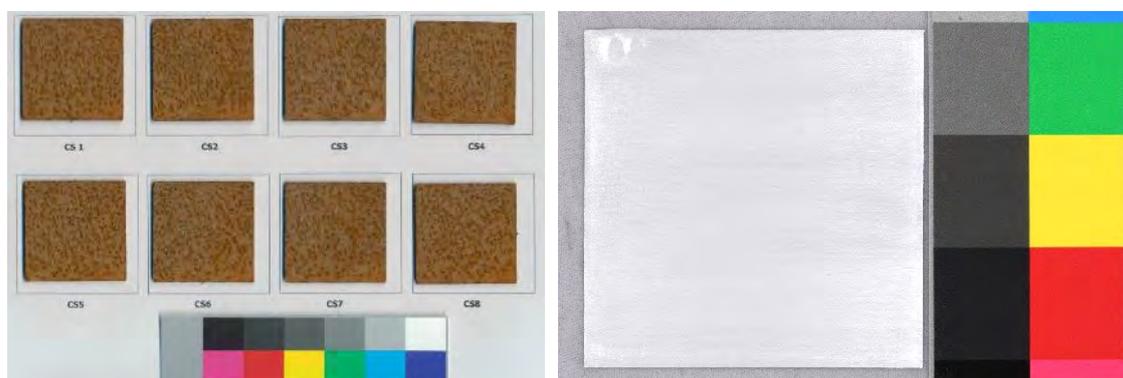
Figure 14 - Scanned image of the weathering steel samples (left) and picture of an aluminum coupon (right).

For the visual characterization of all samples, a scanner CanoScan 8800F was used and a Kodak® color and grey control chart. A resolution of 600 dpi was applied and the white balance set on a white paper (Figure 14). Each sample was also recorded with a digital camera CANON EOS 500 and a 60 mm lens. Standard conditions were set by using a light box (mini Studio 60 x 60 cm, 2 fluorescents lights 35 w 5500°K from Kaiser®). Each picture was taken with a color and grey control Kodak® chart (Figure 14). White balance was performed later on for each alloy series with Photoshop® using the grey control chart.

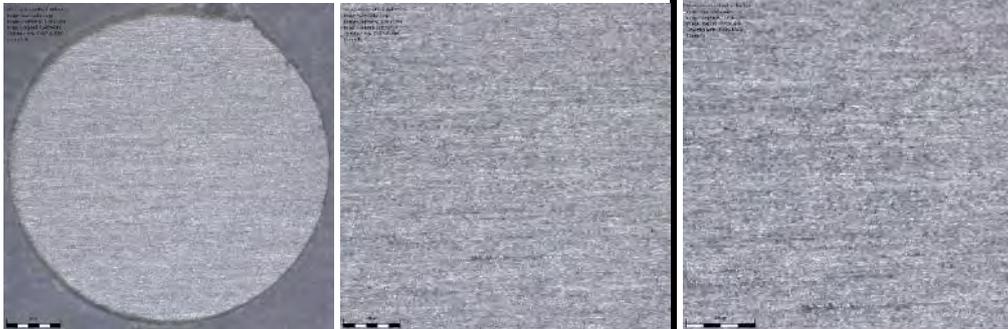
Figure 15 - Aluminium sample A1 zone A, magnification 46X, 96X and 145X (from left to right).

Optical microscopy (Olympus micro LC) was carried out on all samples. Four zones (A\_B\_C\_D) were assessed for each coupon with help of a perforated paper mask (the diameter of each zone is 5 mm). Grinding marks were positioned horizontally to the lens and visualized under three different magnifications: 46X, 96X and 145X (Figures 15-16).

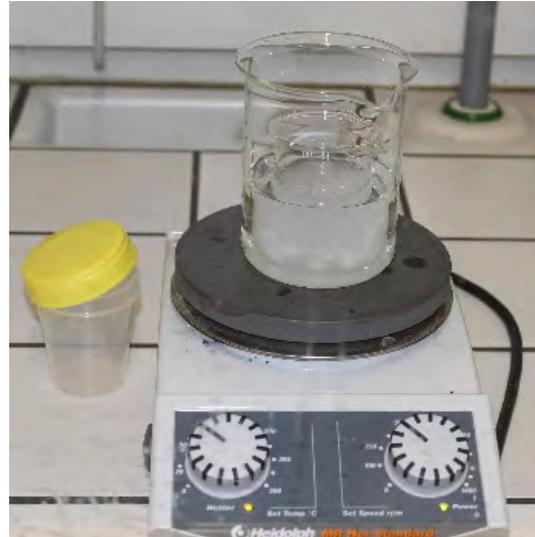
Figure 25- preparing the microcrystalline wax solution by heating

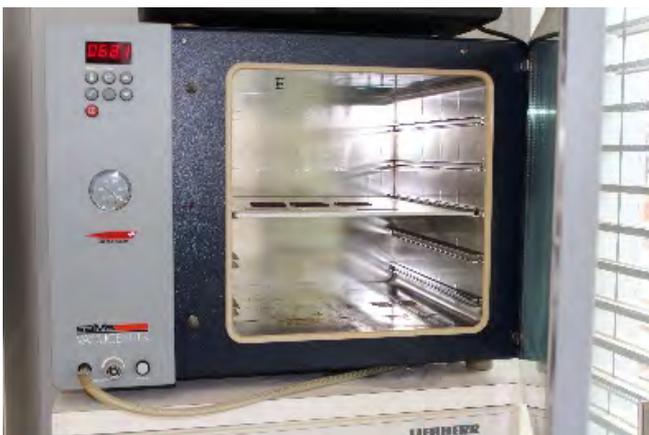
Figure 26 - preliminary heating of the corroded samples before wax coating

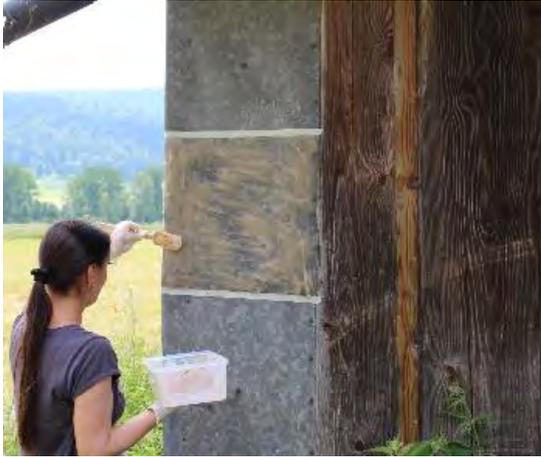
Figure 30 - application of the biopatina gel on the northern side of the absinthe dryer

The treatments were performed in June 2017 (Table 10). In both cases (absinthe dryer and Farelhaus), the test surface was degreased with a non-woven textile impregnated with acetone to achieve a good compatibility of the metal with the aqueous biopatina gel and eliminate a maximum of loose particles (dust, less adherent corrosion products). The test zone was delimited using an adhesive tape. The surface was decontaminated using an ethanol spray. The biopatina gel was applied homogenously with a spatula to obtain a regular gel thickness of a few mm. Then, the test zone was successively covered by a wet gauze, bubble pack and a solar film to avoid strong heating and drying of the underlying gel (Figures 30-34). After treatment the gel was removed first of all mechanically and then with water, before using a nylon brush to eliminate all residues.

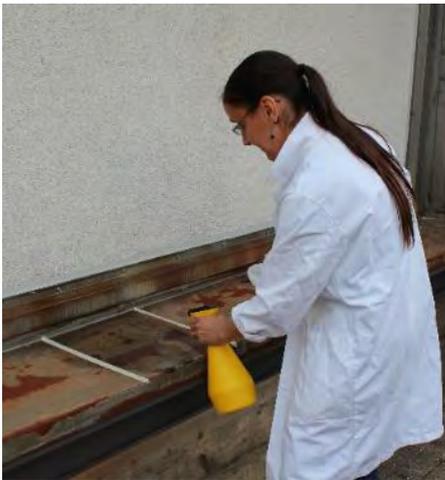
Figure 32- Surface decontamination before the biopatina gel application

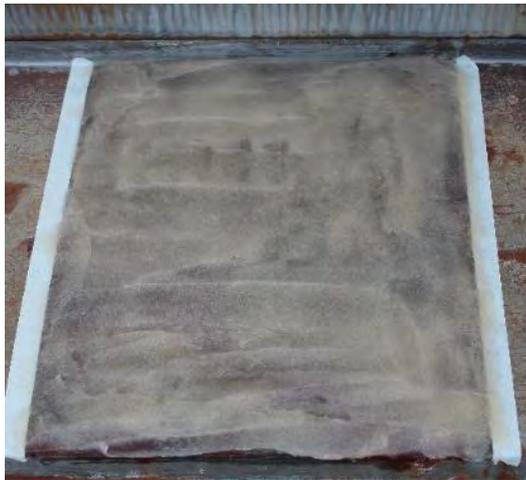
Figure 33- After application of the biopatina gel and before surface protection of the bench located on the north east side

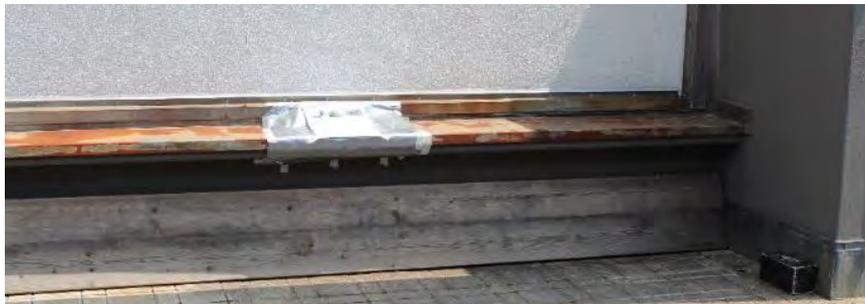
Figure 34- Setting during biopatina treatment

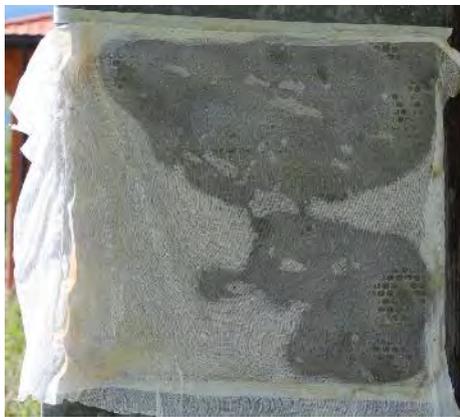
Figure 36- end of the treatment, before gel removal

Two test zones for the measurements were defined (Figure 35). After removing the outer cover (sunshade) and before removing the gauze covering the gel, it was noticed that the latter began to dry in an irregular manner (Figure 36). The contrast between lighter and darker areas before treatment seems significantly greater after treatment (Figures 37-39). Visual evaluation by light microscopy shows that a lighter layer has formed over the entire treated surface (Table 11).

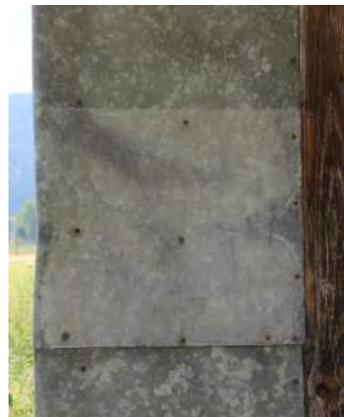
Figure 37- end of the treatment, after gel removal

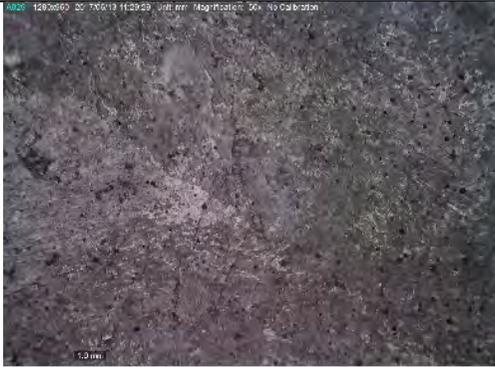
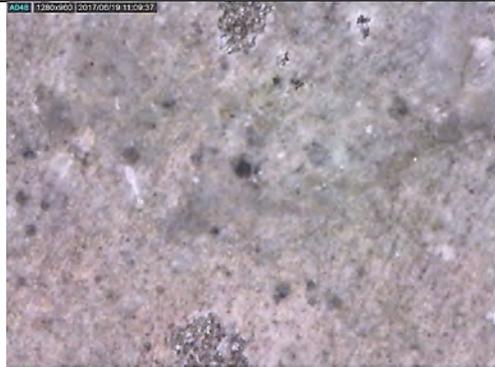
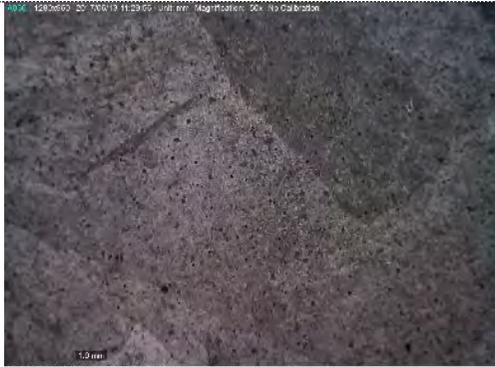
Test zone	zone	Before treatment		After treatment	
		Microphotographie (magnification X50)	Average thickness	Microphotographie (magnification X50)	Average thickness

Table 11- Visual evaluation of the test zone on the northern side before and after biopatina treatment

Since the zinc coating appears to be only slightly oxidized before treatment, the values obtained indicate a zinc coating thickness between 75 and 102  $\mu\text{m}$  on the characterized zones. A significant variation of about 18  $\mu\text{m}$  of the average thickness after treatment is only found in zone 2. This indicates that a passivation layer has actually formed after the application of the biopatina gel. This layer is very thin on zone 1 (limit of detection) and thicker on zone 2.

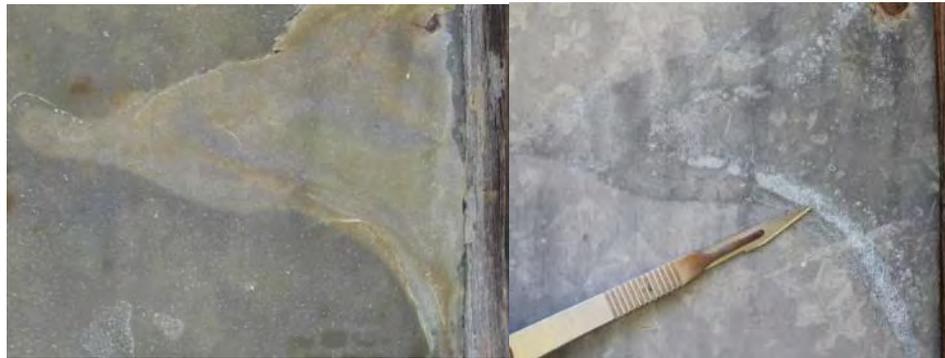
Figure 40- detailed view of the sampled area before gel removal (left) and sample location (right)

Given the small thickness of the layer formed during the treatment, it was taken only in an area where a larger whitish rim of corrosion products had formed (Figure 40). Unlike copper alloys, passivation by the formation of metal oxalates does not occur by the application of biopatina on zinc. In contrast, a characteristic peak of hydrozincite  $Zn_5(OH)_6(CO_3)_2$  was detected at  $1393\text{ cm}^{-1}$  (see Appendix 3: Case study absinthe dryer, Boveresse). It is an insoluble light grey zinc carbonate and therefore protective. This species seems to be mainly present.

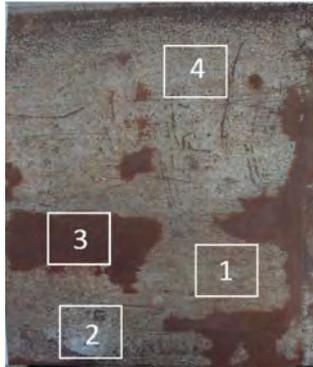
Figure 41- Localization of the measured areas on the bench

The test area on the bench was evaluated before and after biopatina to assess the effect and the performance of the treatment. Comparative measurements were carried out on the following zones (Figure 41).

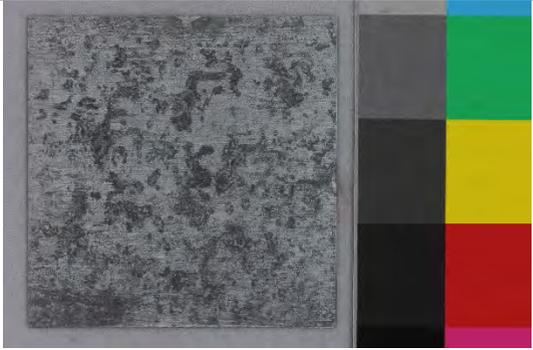
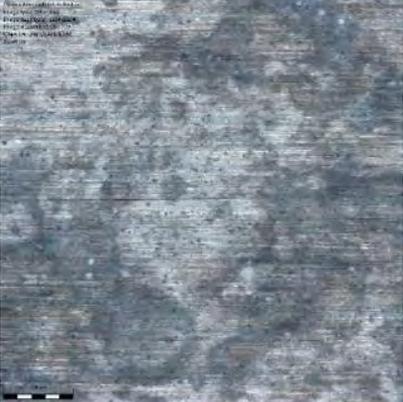
<p style="text-align: center;">Sample Z1, General view</p>	<p style="text-align: center;">-----</p>

<p style="text-align: center;">Sample Z1, zone B, X96</p>	<p style="text-align: center;">-----</p>

<p data-bbox="533 683 840 715">Sample Z1 zone B, x650 (SE)</p>	<p data-bbox="1041 526 1388 542">-----</p>

<p data-bbox="1635 518 1937 550">Sample Z1 zone B, x650 (SE)</p> <p data-bbox="1635 874 1937 906">Sample Z1 zone B, x1500 (SE)</p>
<p data-bbox="174 1085 212 1117">T4</p> <p data-bbox="174 1204 291 1236">biopatina</p>

The biopatina treatment induced the development of a heterogeneous white-grey corrosion product layer. This layer is about 4  $\mu\text{m}$  thick. Microscopic observation shows that poorly adherent white corrosion products also formed (Table 14). The average colorimetric values indicate that the surface tends to get darker with the treatment. A slight decrease in lightness (Figure 47) and an evolution on the blue-yellow axis towards yellow (Figure 48) can be observed after biopatina treatment. This difference is visible<sup>13</sup> ( $\Delta E = 13.65$ ).

Outdoor exposure induces on the biopatina treated samples the development of microscopic dark spots which alternate with poorly adherent white corrosion products (table 14).

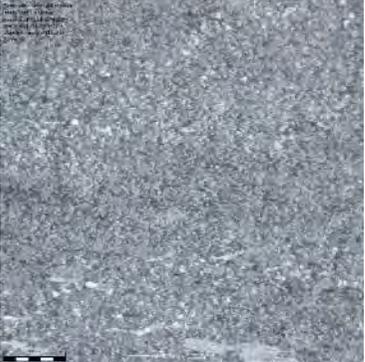
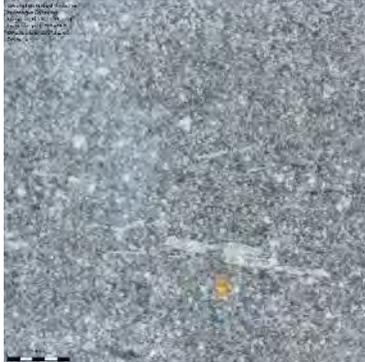
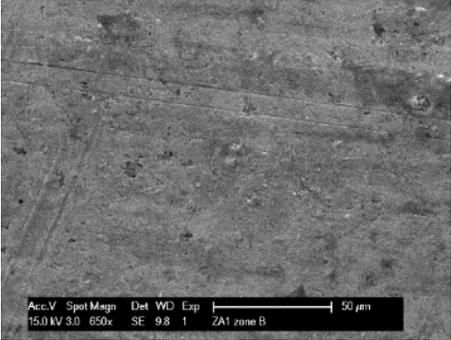
<p data-bbox="510 628 792 655">Sample ZA1, general view</p>	<p data-bbox="1032 539 1205 549">-----</p>

<p data-bbox="517 1059 792 1086">Sample ZA1, zone B, x96</p>	<p data-bbox="1115 884 1301 893">-----</p>

<p>Sample ZA1, zone B, x650</p>

<p>Sample ZA1, zone B, x1500</p>	<p>-----</p>

The samples treated with biopatina formed a homogenous patina, which is slightly less dark than on the untreated exposed samples. The average colorimetric values confirm that the surface gets darker without a biopatina treatment (Figure 52). At a microscopic scale the untreated samples show a very similar corrosion product morphology to their state before exposure (Table 16).

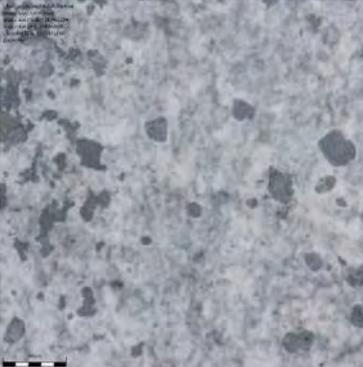
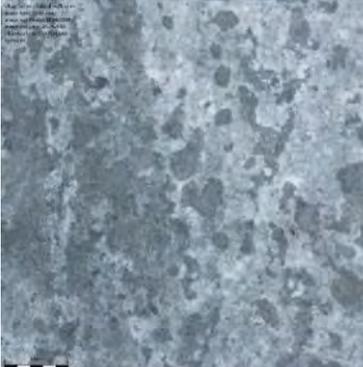
<p>Sample ZA5, general view</p>

<p>Sample ZA5, zone B, x96</p>

The biopatina treatment induces the development of a heterogeneous white-grey corrosion product layer. The overall thickness of this layer is slightly higher than the natural intact corrosion layer on the untreated samples. Microscopic observation shows that white corrosion products which seem poorly adherent develop on the surface. This layer is discontinuous, a lot of porosities can be seen. SEM imaging shows the development of specific corrosion products and crystallizations (table 16, which can be observed at magnification X1500). Before treatment the samples show characteristic peaks attributable to carbonate of hydrozincite at 1495/1575, 1378/1384, 1040/1036, 830/826  $\text{cm}^{-1}$  (Figures 53-54) The peak at 692/670  $\text{cm}^{-1}$  might arise from hydroxide deformations.

In the case of samples treated with biopatina, the superficial whitish corrosion layer which formed during the treatment, tends to get off. This could explain the more homogenous and darker appearance after the 6-month exposure. The same surface morphology could not be observed by SEM after treatment. This observation could confirm that a part of the corrosion layer was modified or disappeared with exposure.

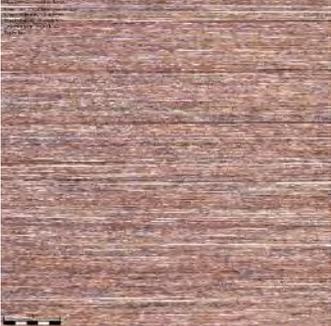
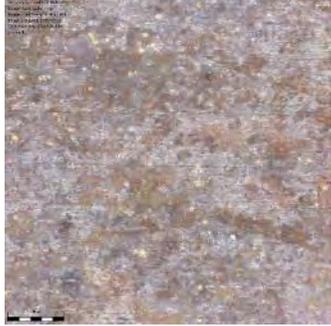
<p style="text-align: center;">General view, sample C6</p>	<p style="text-align: center;">-----</p>

<p style="text-align: center;">General view, sample C6</p>

<p style="text-align: center;">Sample C6, zone A, X96</p>	<p style="text-align: center;">-----</p>

<p style="text-align: center;">Sample C6, zone A, X96</p>

<p>Sample C2, zone C, X650</p>

<p>Sample C2, zone C, X1500</p>	<p>-----</p>

No noticeable difference was observed depending on whether the samples had been treated with biopatina or not previously except for some smaller stains which seem to have been induced by the contact with the gel. These stains remain on the surface although the metal was rinsed several times with water (Table 18). Thickness measurements show that no measurable oxide layer formed on the bare metal after biopatina treatment (Table 19). FTIR spectrum indicates the development of copper oxalates with characteristic peaks around 1622 and 1362  $\text{cm}^{-1}$  (Figure 61).

The thickness of the corrosion layer formed after exposure is similar for both treated and untreated samples, the evolution of the thickness after 1, 3 and 6 months is also similar (Table 19). SEM imaging (SE) shows that the morphology of this layer is similar and masks progressively the parallel scratches on the surface (Table 18).

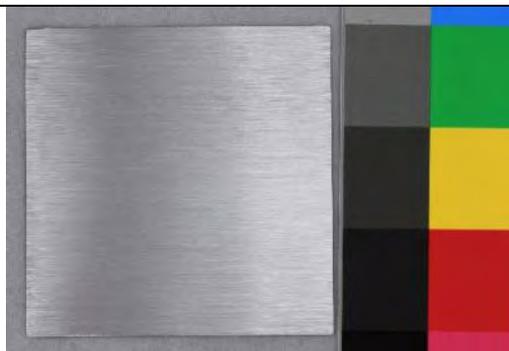
Sample S2, zone C, X3500

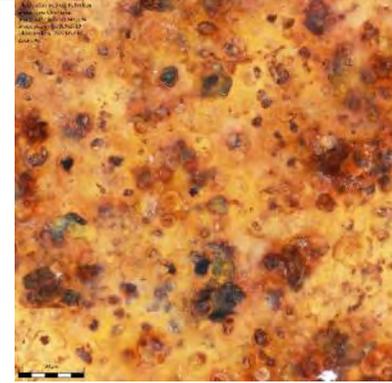
<p>Sample CS2, zone B, X96</p>

Microscopic observation shows that isolated yellow-orange corrosion products formed as well as very small dark-bluish spots when the samples are treated with biopatina. A bigger amount of brownish-red corrosion products is also visible. The colorimetric measurements indicates a slight increase of lightness after treatment and an evolution on the green-red axe (towards red), Figure 90-91.

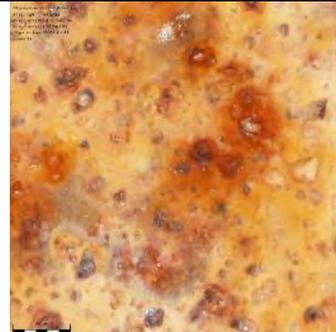
<p>Sample CS7, zone B, X96</p>

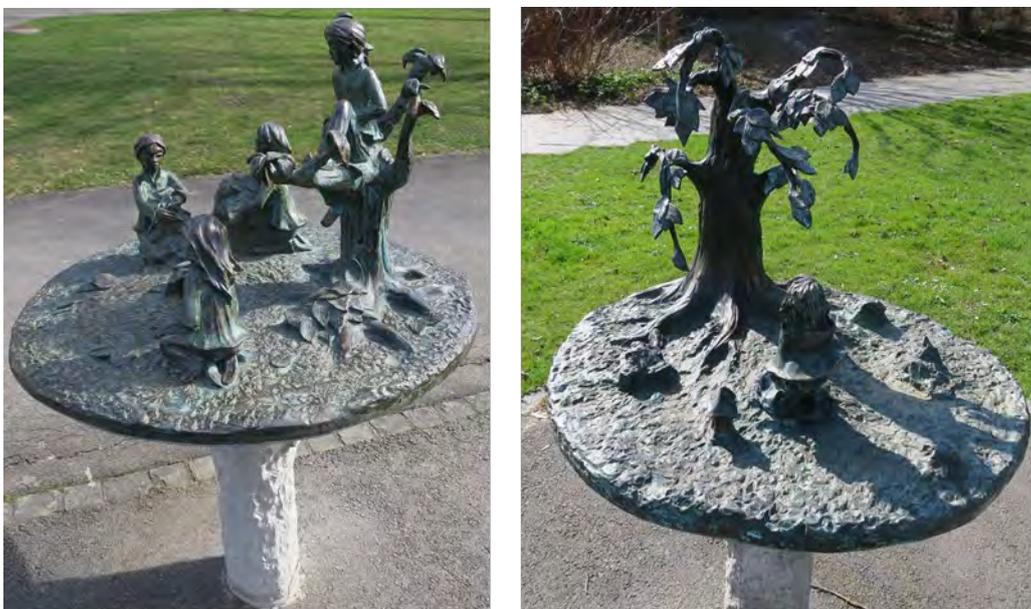
Figure 119 : pictures of a treated (left) and an untreated (right) object

We observe here a larger range before and after treatment. More precisely, the tree trunk goes to a more blue-green stain after treatment, typical color characteristic of vert-de-gris forming in urban environment. The visual aspect of the children and the support do not change. On the opposite, the leaves go from blue to brown (Figure 119-120).

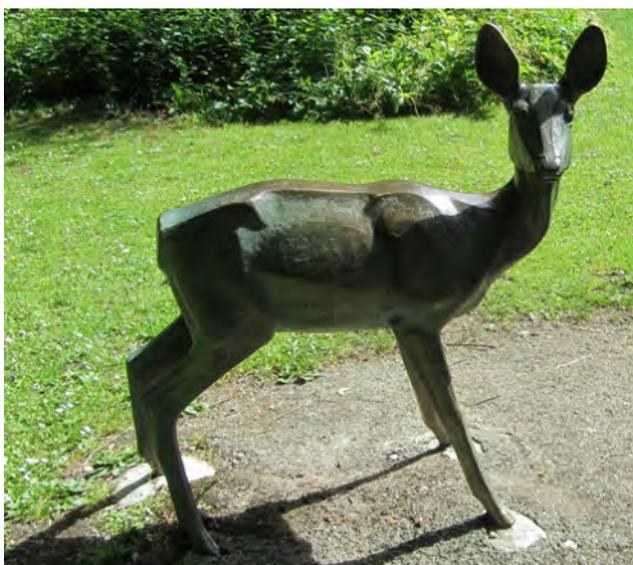
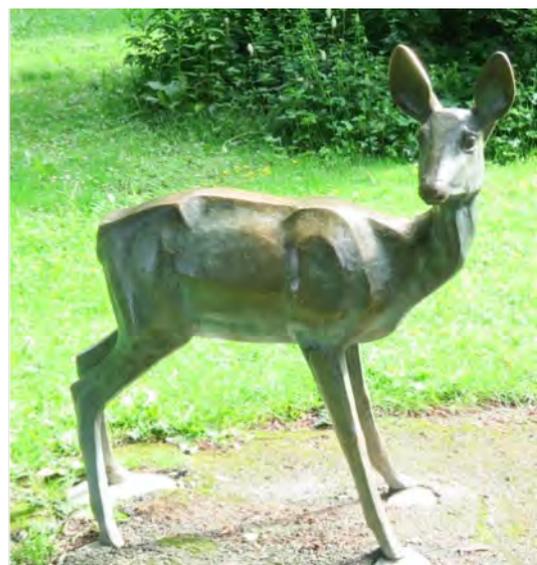
Figure 121 : deer bronze object before (left) and 3 years after treatment (right)

Colorimetric measurements were carried out to evaluate the aesthetics and homogeneity of the treatment (Figures 121-122). Infrared analyses were also carried out, in-situ and in laboratory with samples (Figures 123-124).

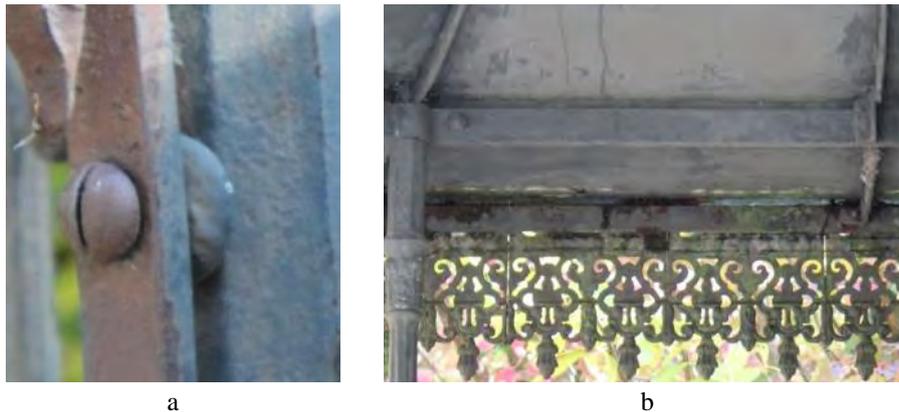
Fig.1 : (a) Mounting of the railing in the lower part of the bandstand, (b) detailed view of the inner roof structure.

It has an open octagonal structure. It is composed of a railing in the lower part and is surmounted by a canopy-shaped roof. The lower edge of the roof is adorned with a decorative frieze. The railing elements just like the decorative frieze seem to have been made of cast iron as well as the pillars probably. The repetitive elements of the frieze were molded by segment and then screwed on the rim of the roof (Figure 1a). The very structure of the roof is an assembly of rolled iron sheets (Figure 1b). A small stone staircase allows to climb in the kiosk. This bandstand comes from the rue de la Boine in Neuchâtel and was in the garden of Madame Gueissaz.

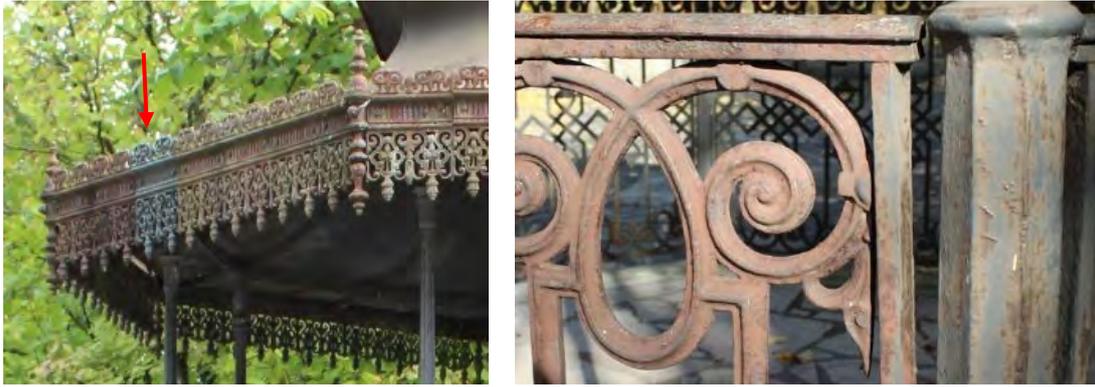
Fig.2 : localisation of a blue painting test / Fig.3 : detailed view of the two different colors which can be observed on the railing

Paint areas generally appear to be a very dark green blue color. Note that an entire area of the guardrails on either side of the entrance has a redder color at the volutes than the rest of the surface (Figure 3).

An area on the decorative roof frieze corresponds to a segment that appears to have undergone a bluish repainting test

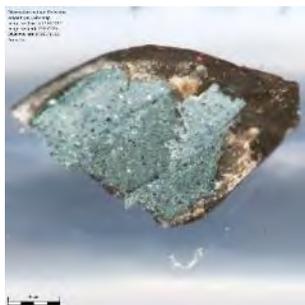
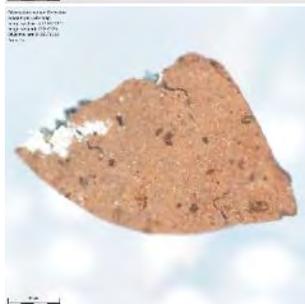
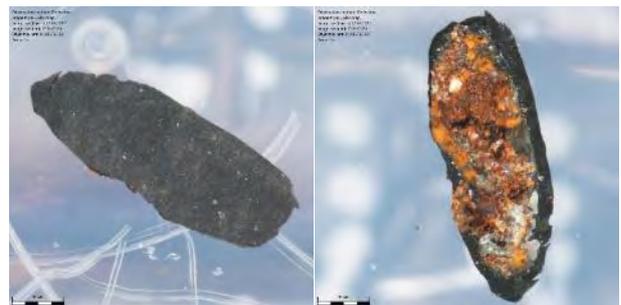
Fig.4 : samples, observations backside (left)-upper-side (right) and related cross-sections of a) volute of the railing (sample 1), b) pillar of the railing (sample 2), c) horizontal roofpillar (sample 3) et d) roof sheet (sample 4). Original enlargement of stereoscopic observations x121. Original enlargement of stereoscopic observations x361 (a-b-d) et x386 (c).

Four samples were taken and prepared in cross sections. The embedding was carried out with an epoxy resin of Araldite® type. Sampling was carried out on the various components of the kiosk: railing (Figure 4a and b), roof crossbar (Figure 4c) the roof plate (Figure 4d). As two different hues were observed at the railing level, two samples were taken from a brownish area and a darker area to compare the stratigraphy and constituent materials. The aim was to determine whether the difference in hue was related to a particular degradation of the paint or not, knowing that brown areas have a slightly more powdery appearance than other areas. The objective was also to better understand the delamination between the possible different layers of paint especially on the inside of the roof. The samples were observed under a binocular microscope and the cross

The study of the four cross sections makes it possible to affirm at first sight that the difference of color on the railing (more red-brown zone and darker and less altered green parts) is well linked to different paints. Indeed, sampling in a red-brown zone is the only one to have a superficial layer in which are red pigments. It should be noted that the sampling corresponds (n ° 1) is incomplete and that an underlying layer of minium could be observed visually in situ on the corresponding parts of the railing.

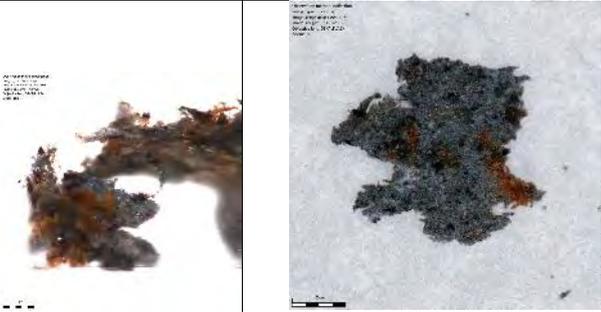
<p>cross-section X434 / sample, external surface, X121</p>
<p><b>Sample 4:</b> ancient metal sheet (left side of the wheel)</p>

<p>cross-section X361 / sample, external surface, X121</p>

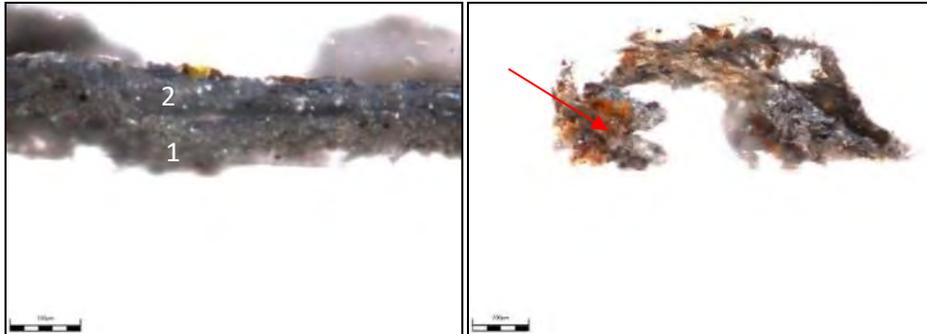
sample 3 (unaltered paint), magnification X434 / fig.28: sample 4 (altered area), magnification X169

The examination of the cross-section indicates that two successive layers (fig. 27) were applied on the iron metallic substrate. The samples collected in an altered area shows that iron corrosion products are present inside the painting layer (red arrow, figure 28).

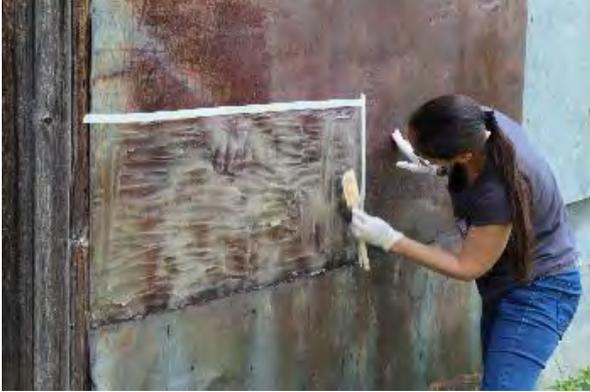
Application of the biopatina gel, western side of the absinthe dryer

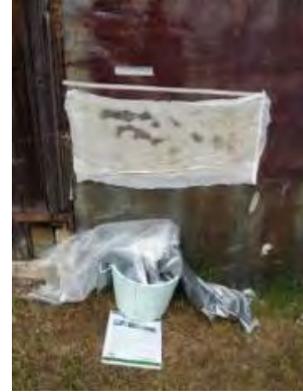
Degraded setting after storm

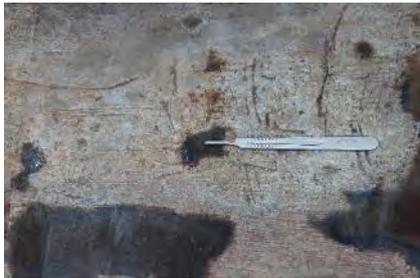
FTIR analysis on a corrosion sample after treatment
